Advanced Composite Vertical Fin for L-1011 Aircraft

*Design, Manufacture, and Test
(Executive Summary)*

A. C. Jackson

CONTRACT NAS1-14000
SEPTEMBER 1984

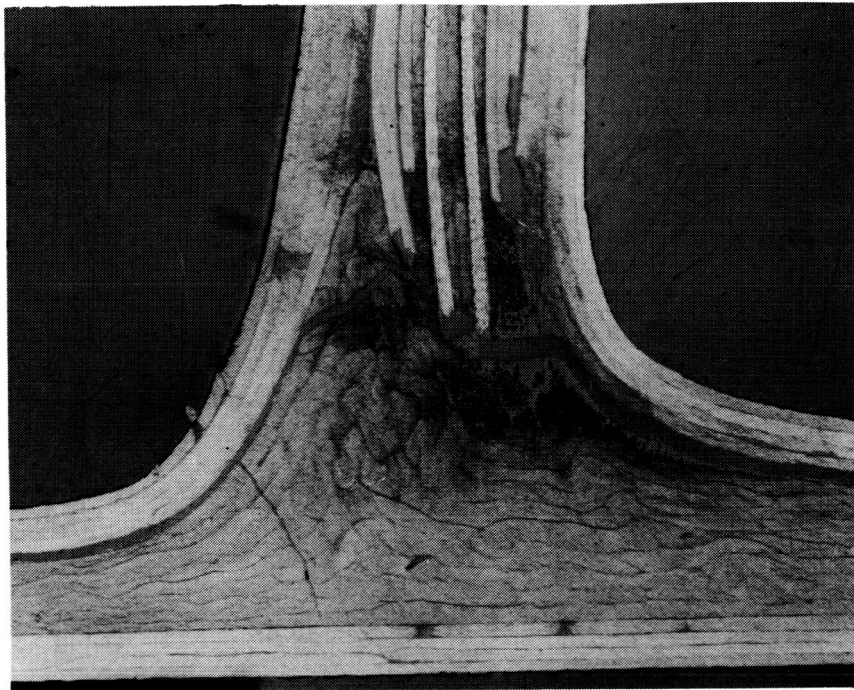
Figure 29. - Photomicrograph of section from GTA No. 1 front spar cap, right side at VSS 278.3.

The first static test resulted in an unexpected failure at 98 percent Design Ultimate Load (DUL). Following an investigation into the cause of the failure, a second ACVF (GTA No. 2) was reinforced and the test program continued. The following is an account of the failure analysis of GTA No. 1, reinforcement of GTA No. 2 and the subsequent testing of GTA No. 2.

As a result of the ground test some redesign would be necessary before the fin could be committed to production. A redesign of the spar would include taking all the web plies around into the cap, and the cap would be designed for specified out-of-plane loading. Figure 30 shows a schematic of the original cap and the redesigned cap. It is estimated that a redesign of the spars would add about 15 lbs. This would be due to thicker spar caps when all the web plies are continued into the cap flanges, the elimination of the lower six access holes in the front spar web and the replacement of the front

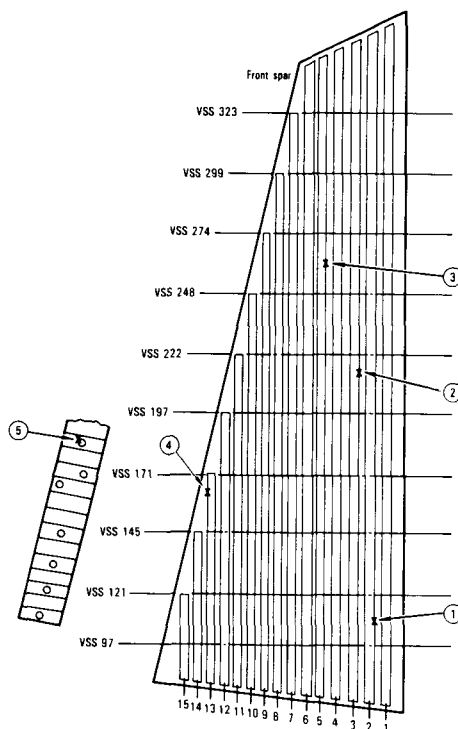
Figure 34. - Impact damage locations.

Impact No. 2 was in the 14-ply skin area. Four impacts were required to obtain visible damage. The first impact was at 13.33 ft-lb. Some damage was evident ultrasonically. A second impact at 8.64 ft-lb showed no evidence of change ultrasonically. A third impact, now back at 13.33 ft-lb, gave no visible damage but increased the damage area determined ultrasonically. A fourth impact was made, but at an energy level of 18.95 ft-lb. Visible penetration through the thickness occurred.

Impact No. 3 was in the 10-ply skin area. This area was impacted at 13.33 ft-lb also. One impact caused visible surface damage.

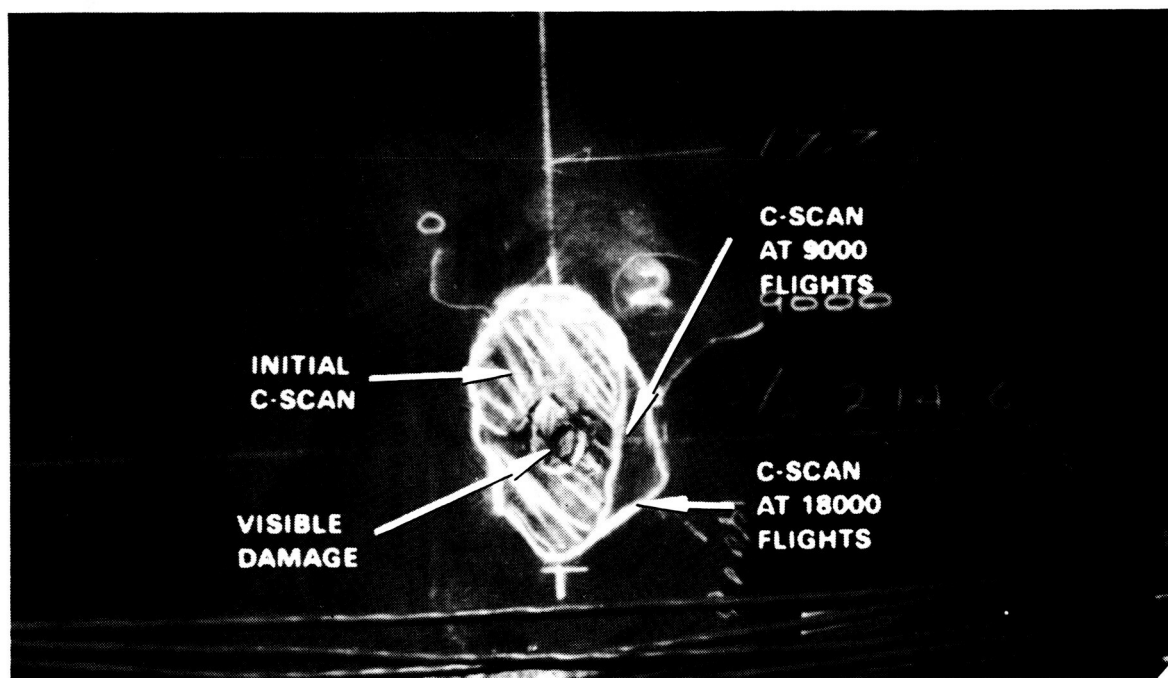
Figure 35. - Impact No. 2 damage growth.

At the completion of each one-quarter lifetime (9000 flights) of fatigue loading the impacted areas were inspected ultrasonically and damage growth, if any, marked on the part. The damage and growth for impact No. 2 shown in figure 35 is typical of that which occurred at all five locations. Most growth occurred during the first half lifetime of fatigue cycling and could only be determined ultrasonically.

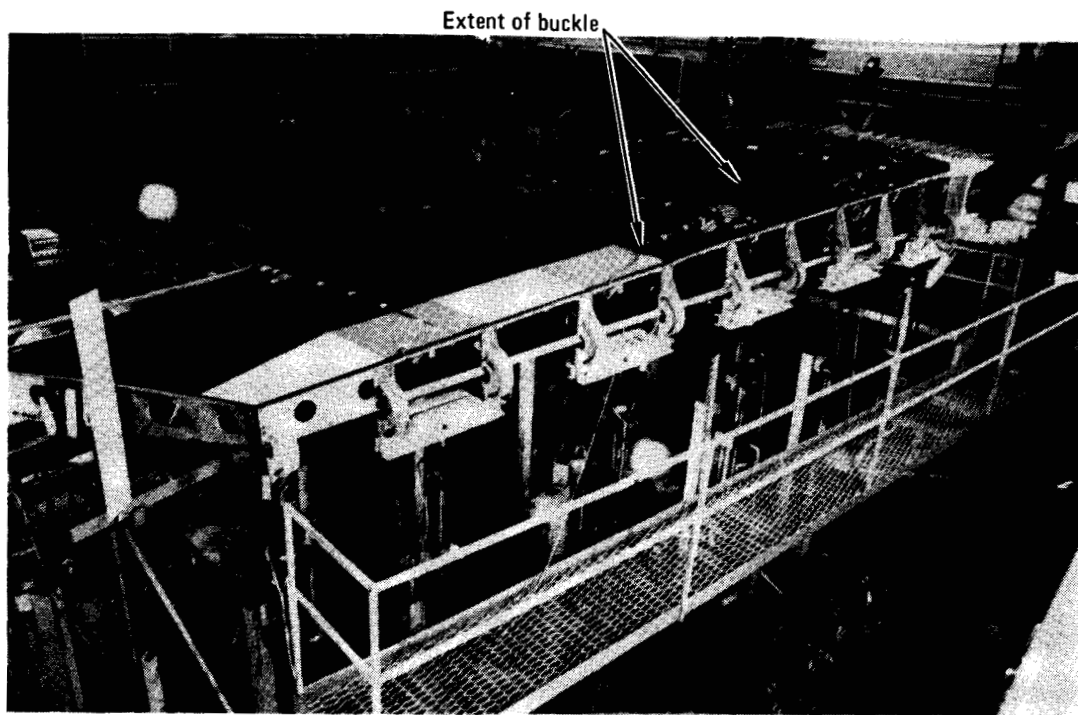
Figure 38. - Fin box at the moment of failure.

The initial failure was caused by high interlaminar stresses induced by shear buckling of the trapezoidal skin panel between VSS 222 and VSS 248 and between the front spar and stiffener No. 10. The high speed film showed that the skin buckled up just above VSS 222 and the buckle then propagated outboard and inboard as the skin and stiffener separated. Shear buckling was measured by a pair of back-to-back shear rosettes in the bay below VSS 222. The strain gage plots shown in figure 39 indicate that shear buckling initiated at about

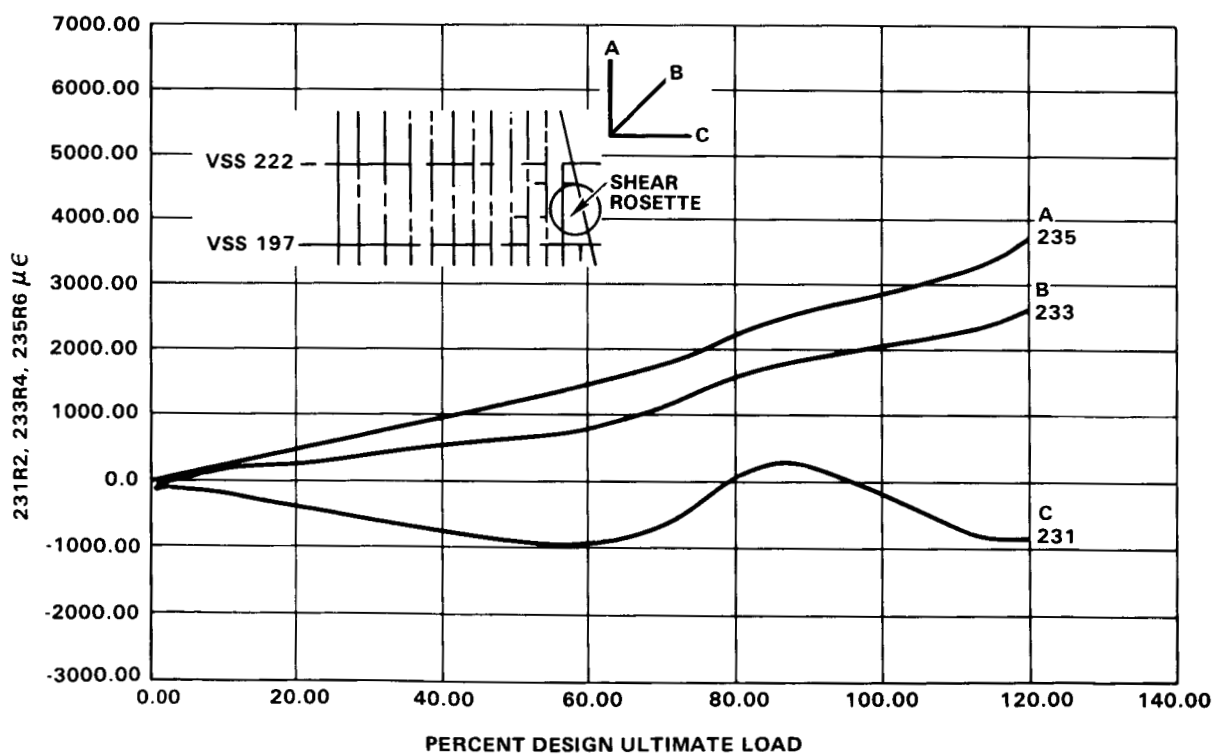
Figure 39. - Shear rosette strain gage plots on tension cover in bay below the failure bay.

design limit load. The Poisson-induced lateral compression strain combined with the shear caused the initial buckling and proved to be more severe than the axial compression and shear on the other cover which did not buckle until 80 percent DUL.
